National Register of Historic Places Registration Form

historic name Walker Bank Building

Walker Bank Building, Salt Lake City, Salt Lake County, UT

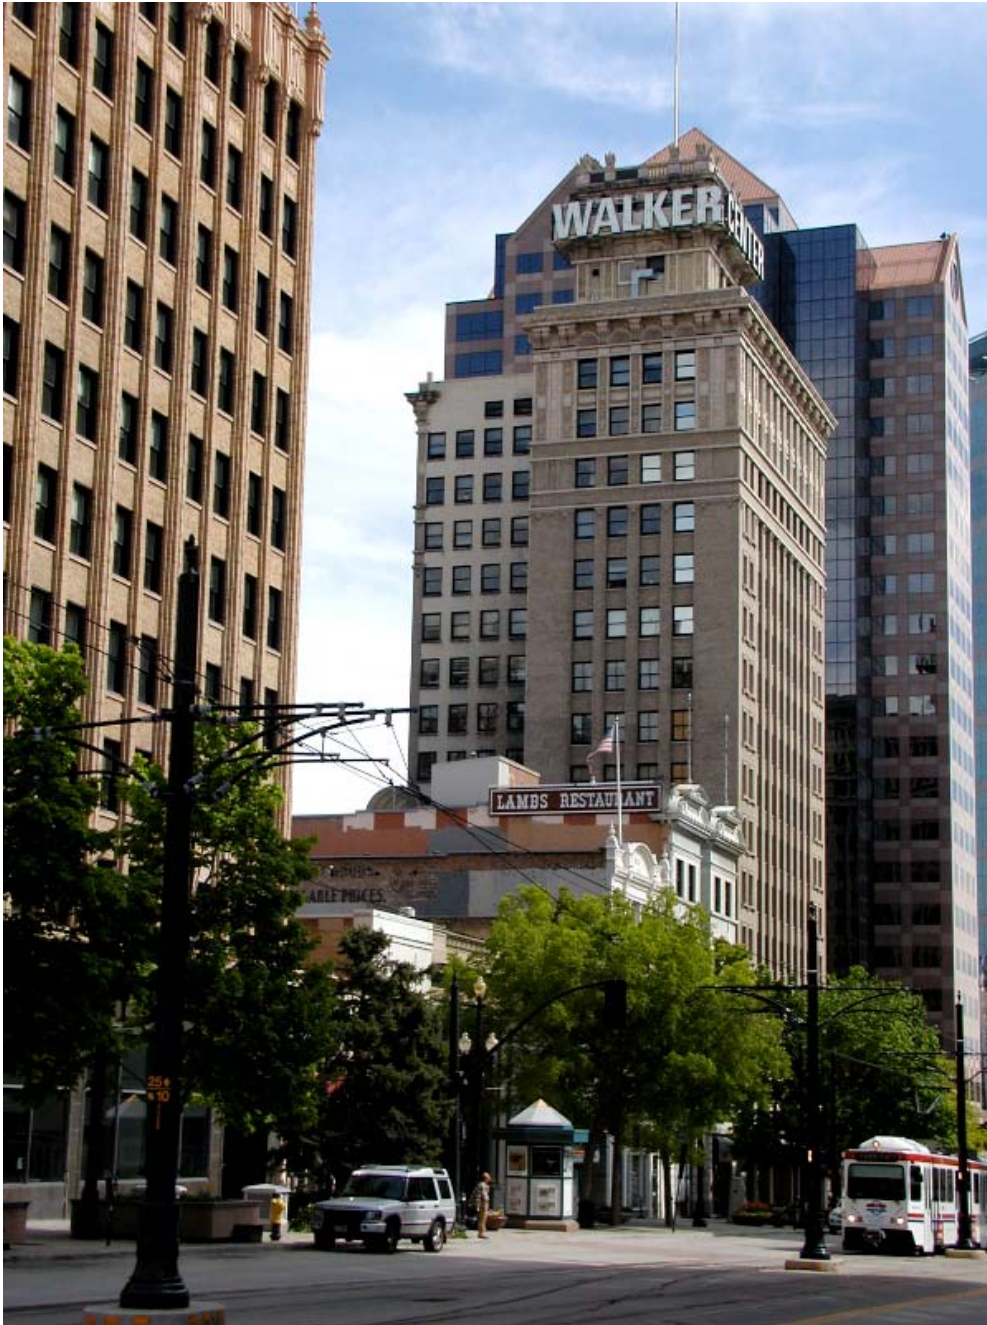
Photo No. 1:

6. North and West elevations of building. Camera facing southeast.

The principal façade of the building faces Main Street and is symmetrical in design. The windows on the ground story are storefront size. A metal canopy above the ground story wraps around the building, covering both of the street-facing facades. A c. 1956 remodel simplified the entrances giving the façade its current symmetry. The metal canopy was another addition from this remodel, which included work on both the interior and exterior of the building. A secondary entrance for the bank from the south was also removed at this time.² Originally, the first level of the principal façade was somewhat asymmetrical in detailing. The centrally located main entrance to the building was grand in design and detailing. The entrance to the bank was located one bay to the north and was accented with single-story fluted Doric columns. An entrance to the drug store located in the south corner of the building was simpler in design and located in the bay furthest to the south. The name of the building and the name of the bank were carved into the granite over their respective entrances.³ Prior changes to the storefront of the bank's Main Street entrance were made c. 1931, when the name of the bank was officially changed to Walker Bank and Trust Company. Historic photos show what appears to be a two-story metal storefront with fluted columns separating the two bays containing the bank's portion of the Main Street facade. This storefront was removed in the 1956 remodel. Bas-relief lion heads sit above the capitals of the columns for the corner bays, and the farthest east bay on the

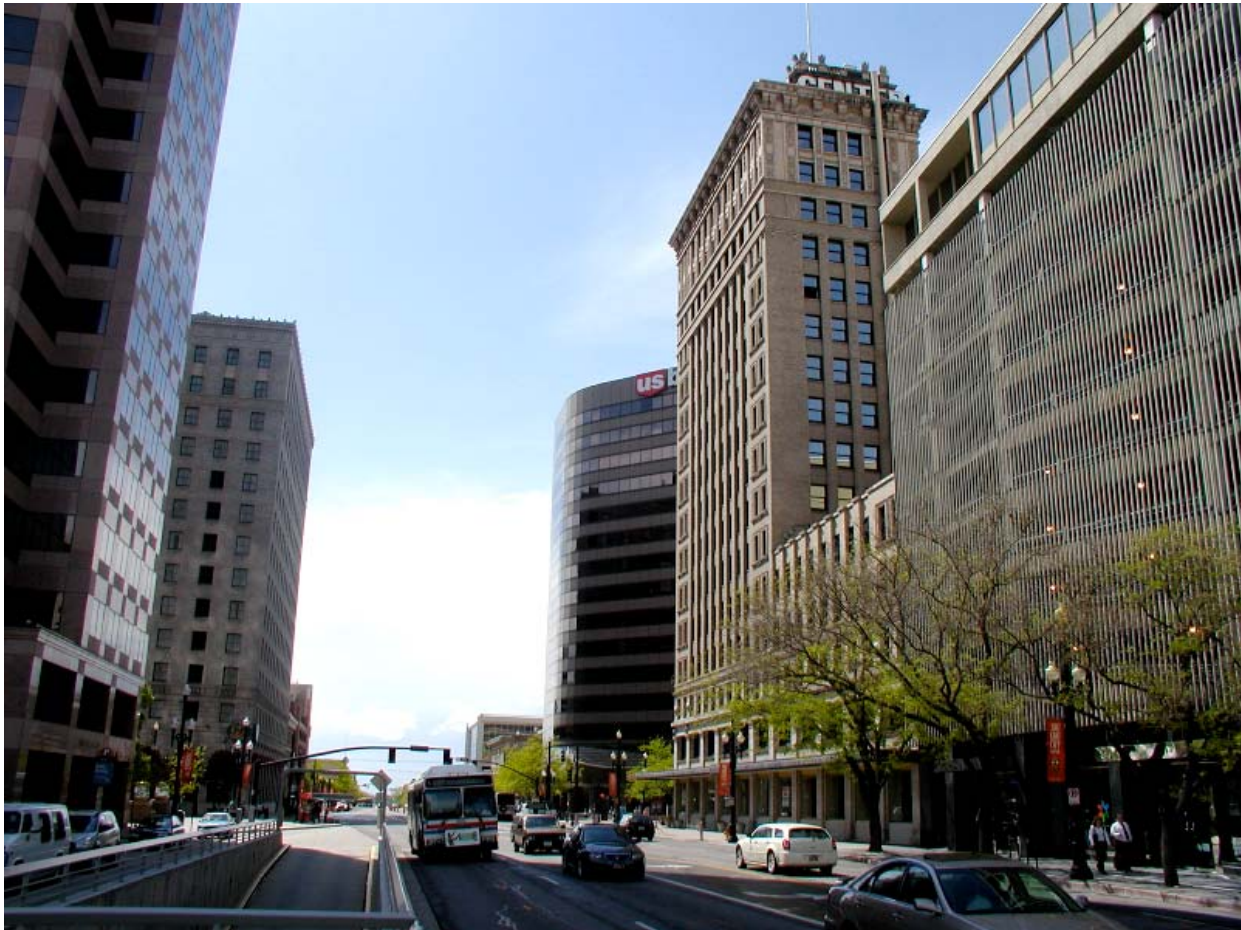
Photo No. 2:

6. South and East elevation of building. Camera facing northwest.

On the east end of the building is a five-story section, visible from the south. The base part of the building was originally three stories; two additional stories were added to the east section c. 1939. The window placement on the third story and the upper parts of the building is symmetrical in design, with the center windows recessed, serving to accentuate the height of the building. The middle part of the building is very limited in decorative details. Terra cotta trims the outside sets of windows. The glass in the windows of the middle and upper parts of the building, most of which are double-hung, is slightly reflective, likely replaced with the last major exterior remodel c. 1956. Narrow belt courses of terra cotta, two beneath and two above the 14th story, serve to distinguish the middle part from the decorative upper part. Decorative corbels beneath the lower belt course and egg and dart molding beneath the upper belt course add a touch of detail to the middle section of the building.

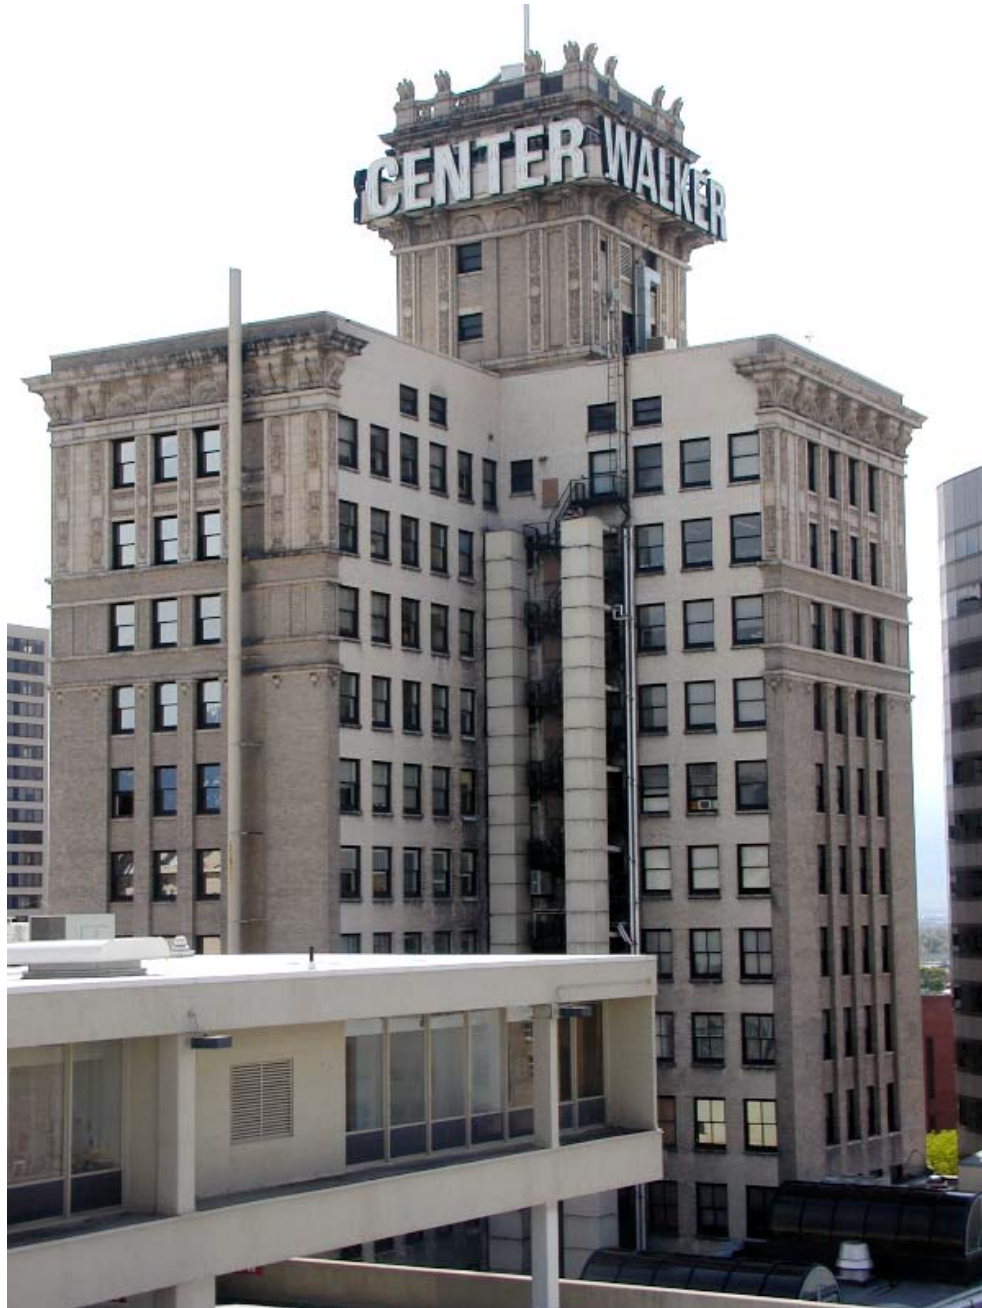
Photo No. 3:

6. East elevation of building. Camera facing southwest.

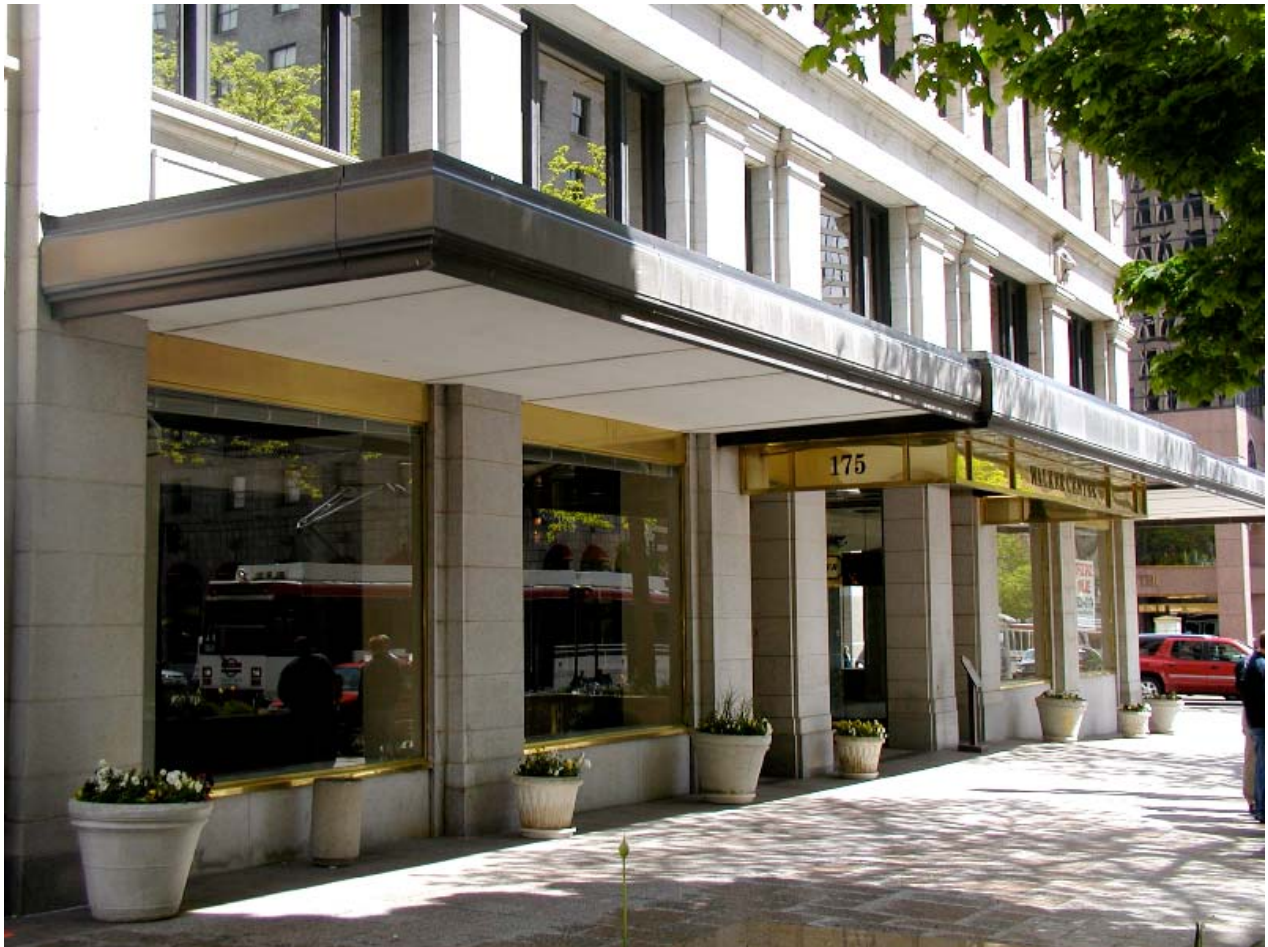
Photo No. 4:

6. Main Entrance and Canopy. Camera facing southeast.

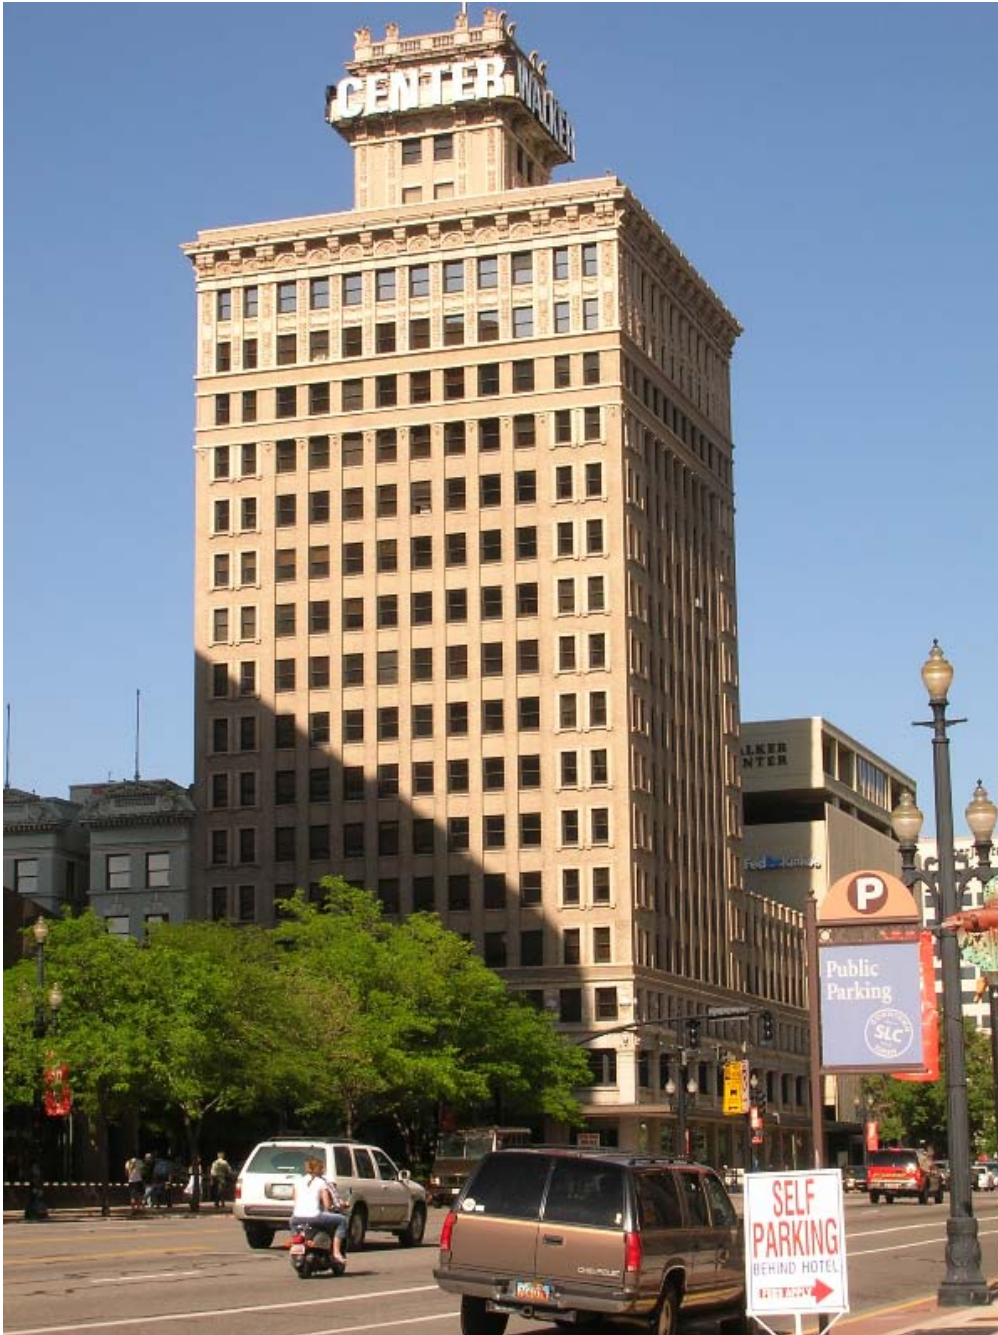
Photo No. 5:

6. West and South elevations of building. Camera facing northeast.

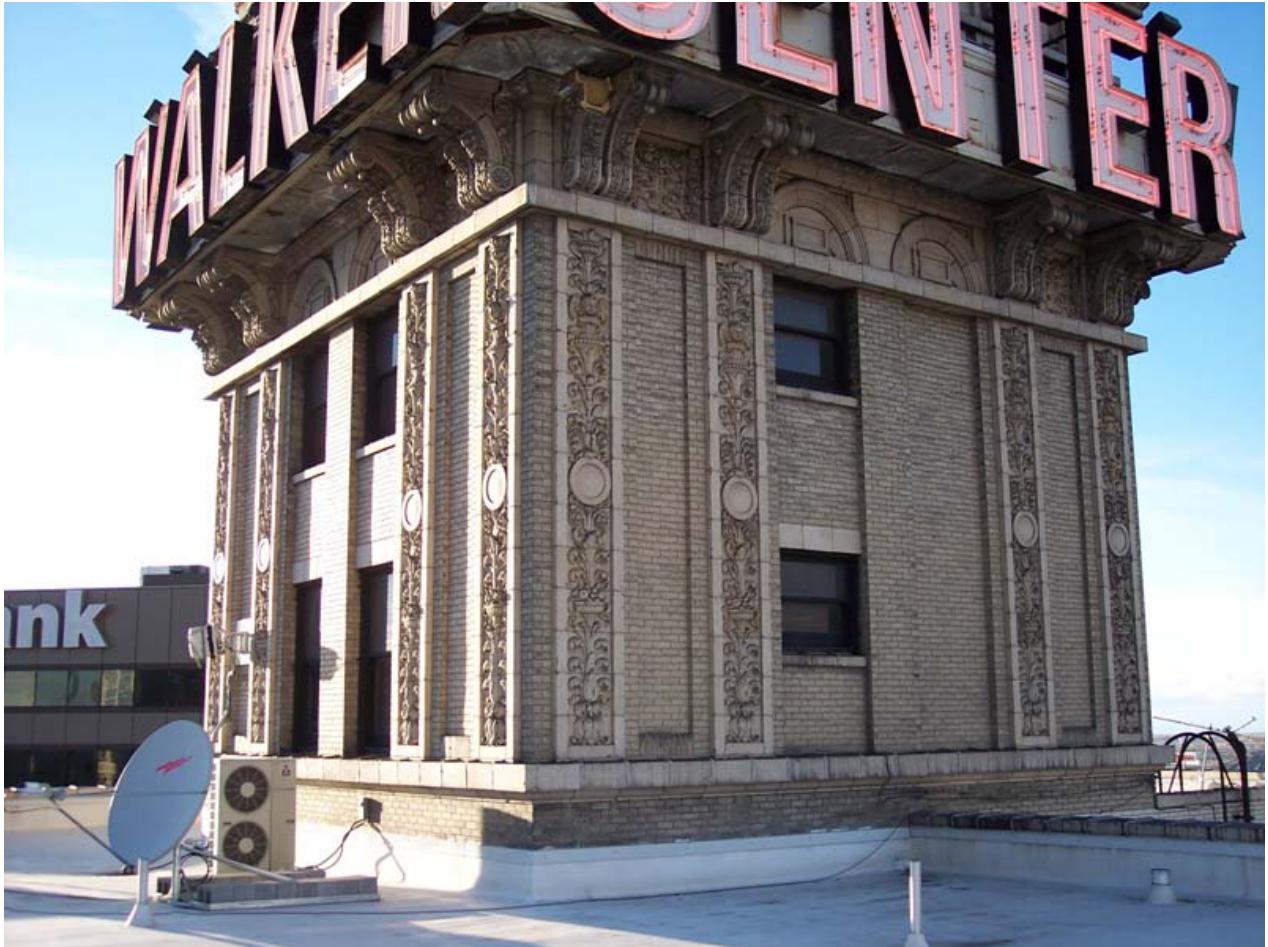
Photo No. 6:

6. Tower Detail. Camera facing northwest.

The three-story recessed tower is decorated in a manner similar to the top two stories. The decorative vertical panels are repeated on the bottom two stories, using the same design pattern as the center panels from the main building. Above each of these panels are two narrow brackets that support the observation platform. These brackets are similar in style to the brackets below the main cornice, but are decorated with a lion head and floral designs. Two rounded segmented arches are located between the middle two brackets, but do not have the decorative detail as those on the main building, containing only a raised rectangle. Additional detail below the observation platform includes egg and dart molding between the brackets but not out around their edges. Neon signs flank the

outside of the observation platform, with 8 foot individual neon letters spelling "Walker" and "Center" on alternating sides. The top story above the observation platform is decorated with wide decorative brackets, egg and dart, and a projecting cornice with lion heads above the brackets, in the same manner as the main cornice of the building. Above this cornice is a decorative balustrade around the perimeter of the three-story tower, with four stone eagles perched on the top of each side. A flag pole currently stands in the center of the roof atop the three-story tower.

The three-story tower has historically been used for the purpose of signage for the Walker Bank, going through three configurations prior to the current one. Each of the signs was illuminated.⁵ The first sign had Walker Bank in a single row of letters, affixed to each of the sides of the tower. The next sign for the bank, installed in the mid 1930s, had larger letters in two rows, with Walker being on top of Bank. Probably the most well known of the sign configurations came in the early 1950's. A 90-foot radio tower was erected in 1947 for use by the KDYL radio and television station, the first television station in Utah. After a few years the station moved the television transmitters, but the tower remained and on each of the three sides were hung letters to spell out Walker, while Bank was around the perimeter of the top of the building's three-story tower. It was this configuration that began the use of the sign as a weather beacon. The sign was blue for clear skies, flashing blue for cloudy skies, red for rain, and flashing red for snow. Visible from most parts of the valley, the flashing sign was seen by travelers as they drove into town. When the building was sold in 1983, the radio tower and the sign were removed. Soon after this, the current sign was erected to indicate the change in name of the building to the Walker Center. The sign was configured to continue the weather beacon tradition. With taller office buildings built around the Walker building, the sign is less visible and only from certain angles.⁶ The current owners are planning to rebuild the sign in the historic radio tower configuration, erecting a new 90-foot tower frame on which to affix individual neon letters spelling out "Walker" on the three sides. Individual letters spelling out "Center" will then be on all four sides of the building's tower. The proposed sign will continue the tradition of changing colors to indicate the weather forecast.

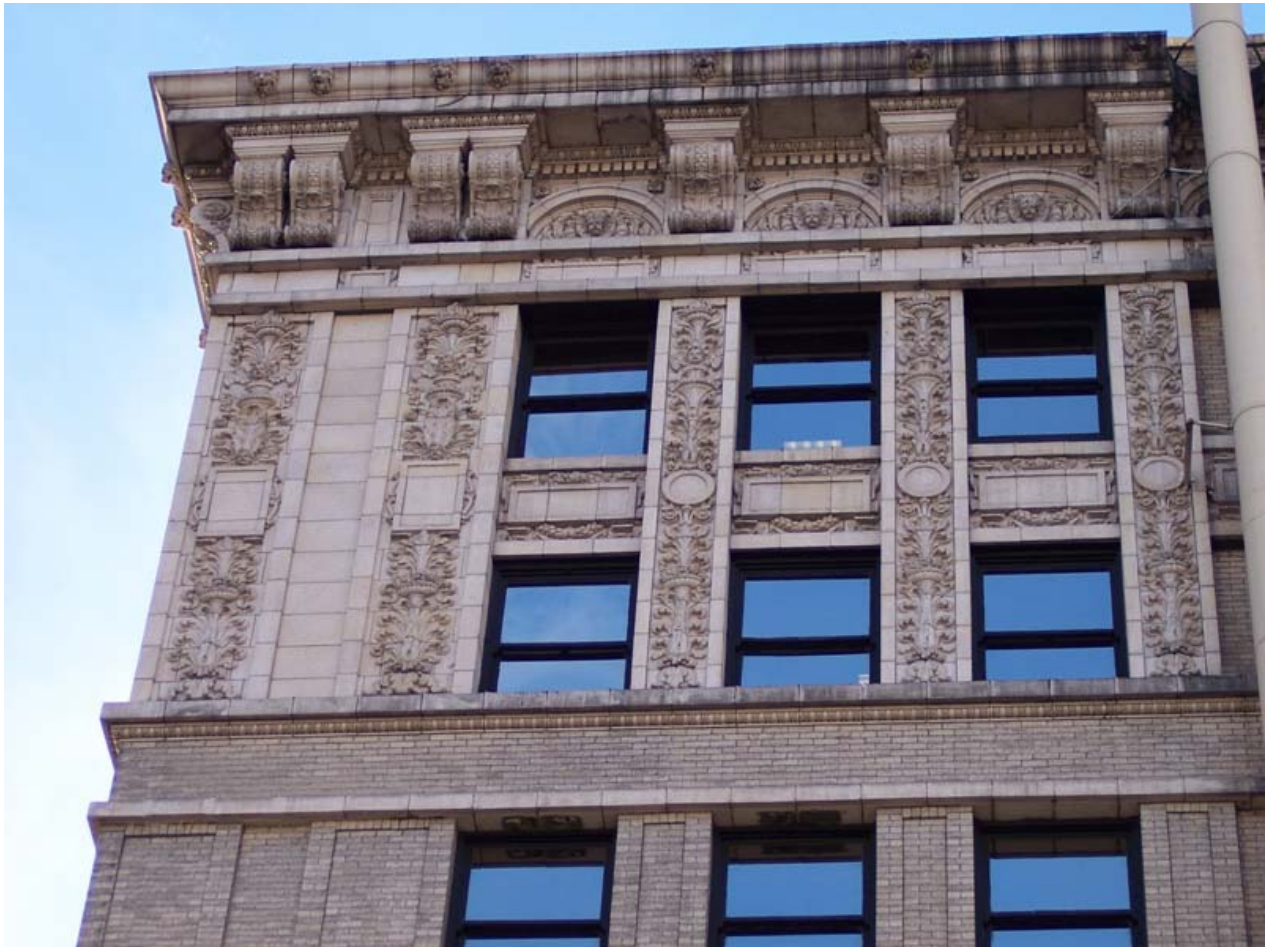
Photo No. 7:

6. Detail of upper stories. Camera facing west.

The upper part, comprised of the top two stories and the recessed three-story tower, has the greatest quantity and variety of decorative enhancements. The decorative detailing of terra cotta is primarily vertically oriented, drawing the eye of the observer upward and further enhancing the height of the building. Two-story decorative panels separate each of the window bays, using a combination of flowers, leaves, and cherubs in the detailing. Slight differences in detail and width distinguish the outer panels from those in the middle. The upper cornice of the building projects out with a modest overhang, and is supported with wide heavily ornamented double scroll brackets. The detail on the brackets includes a vertical strip of fish scale and a center petal medallion. Between the brackets is a row of rounded segmented arches with cherub faces and floral detailing. Egg and dart detailing is repeated above the brackets and arches, running underneath the cornice and around the upper edges of the brackets. The outer edge of the cornice is further enhanced with a lion head medallion above each bracket. The cornice and the decorative panels wrap around the corners of the rear east and north elevations; however, apart from this these rear elevations are not ornamented with granite or terra cotta and are faced only with brick.
